**SUBJECT:** Design Standard (DST) 97-1, Jetway Systems Service Bulletin #091

**JETWAY SYSTEMS®**  
**SERVICE BULLETIN NUMBER 91**

**Rotunda Rigid Frame Weld Inspection for 18" Diameter Rotunda Columns**

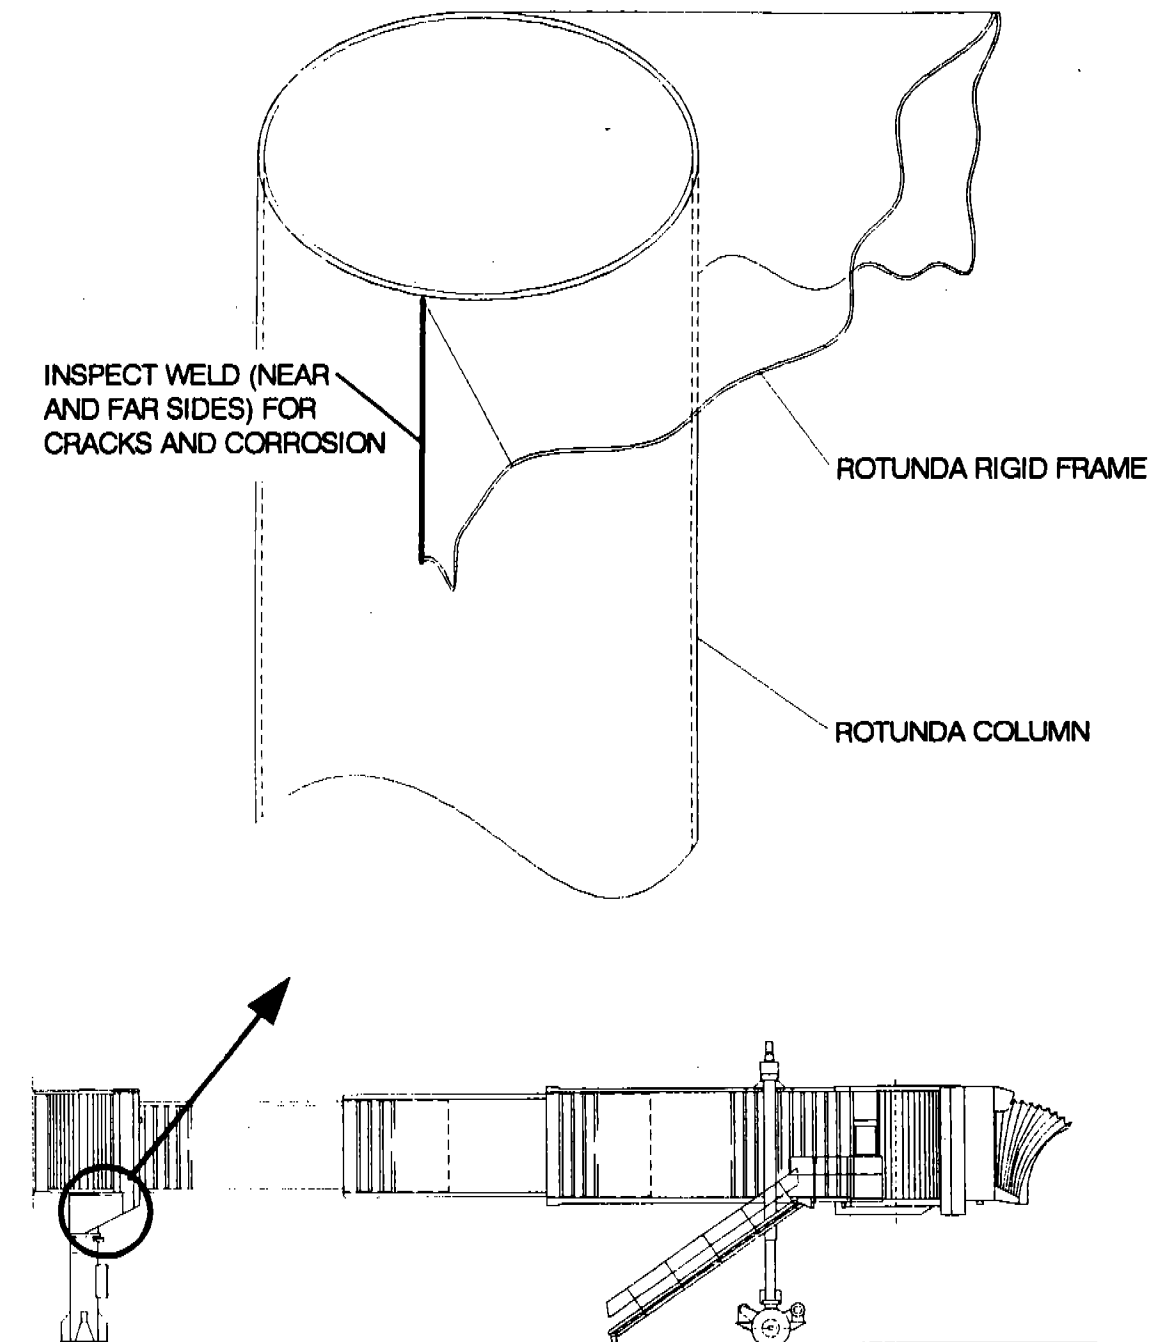
Figure 1. Rotunda Rigid Frame Weld Inspection

Corrosion over time may have damaged a critical rotunda weld on some Passenger Boarding Bridges (PBB) manufactured before 1970. As a result, there is a possible failure of the rotunda rigid frame to rotunda column weld that supports the terminal end of the PBB. This failure may allow the PBB to overturn and could result in damage or injury to property and/or persons.

Refer to Figure 1. Visual inspection can be used to determine the presence of cracks. First, clean all areas to be inspected. Examine the entire weld surface, the interface between the weld bead and the plate and the interface between the weld bead and the pipe (use a lamp if required). Look for signs of cracking in or around the weld. Acceptable welds shall be free of cracks, rust and corrosion.

For rigid frames exhibiting cracked welds, the PBB must be taken out of service and the weld procedure outlined in Section F must be implemented.

Jetway Systems recommends the following: 1. Carefully examine the rotunda rigid frame welds, using the procedures listed in Section D; 2. If cracks are found, complete the repairs per Section F. If a crack is found on one side of the rigid frame, then the repair should be made on both sides of the rotunda rigid frame; 3. Report all findings per Section E; 4. If no cracks are found, continue inspection on a quarterly basis.
